RAHWAY RIVER BASIN
RAHWAY RIVER WEST BRANCH
ESSEX COUNTY,
NEW JERSEY

ORANGE RESERVOIR DAM

NJ 00361

PHASE 1 INSPECTION REPORT NATIONAL DAM SAFETY PROGRAM

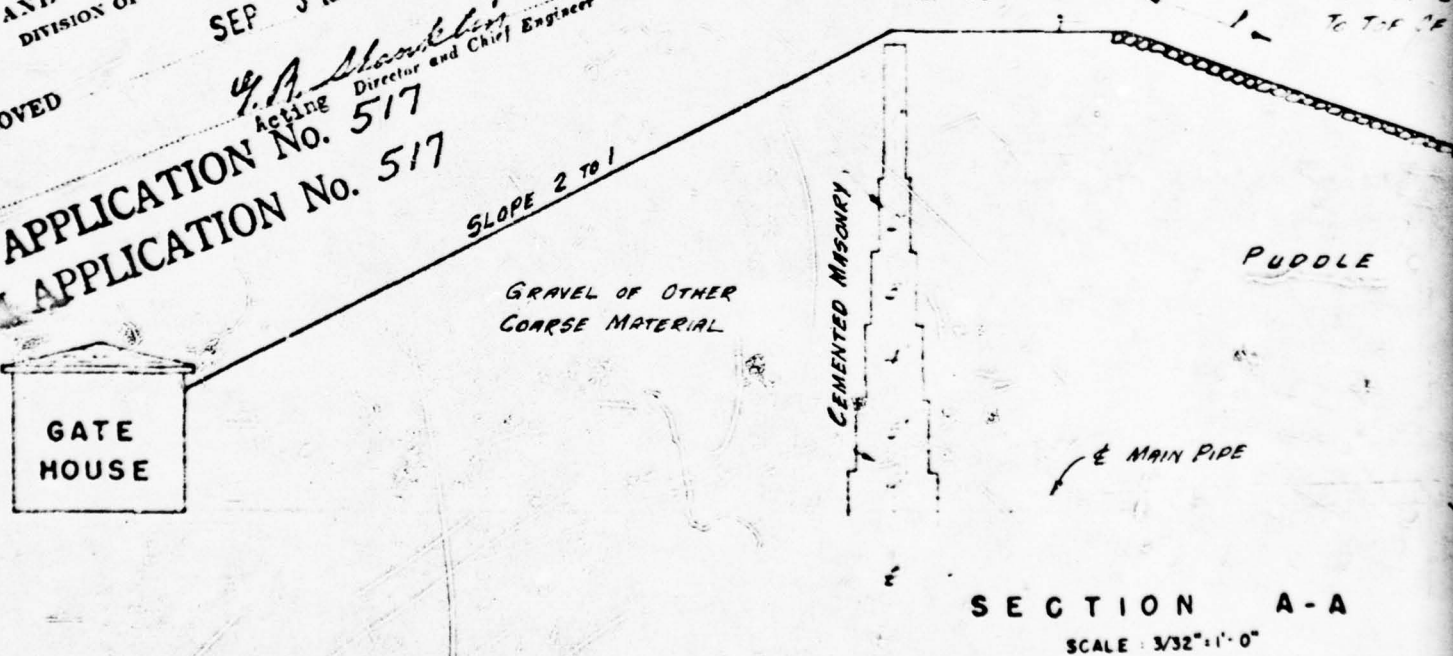
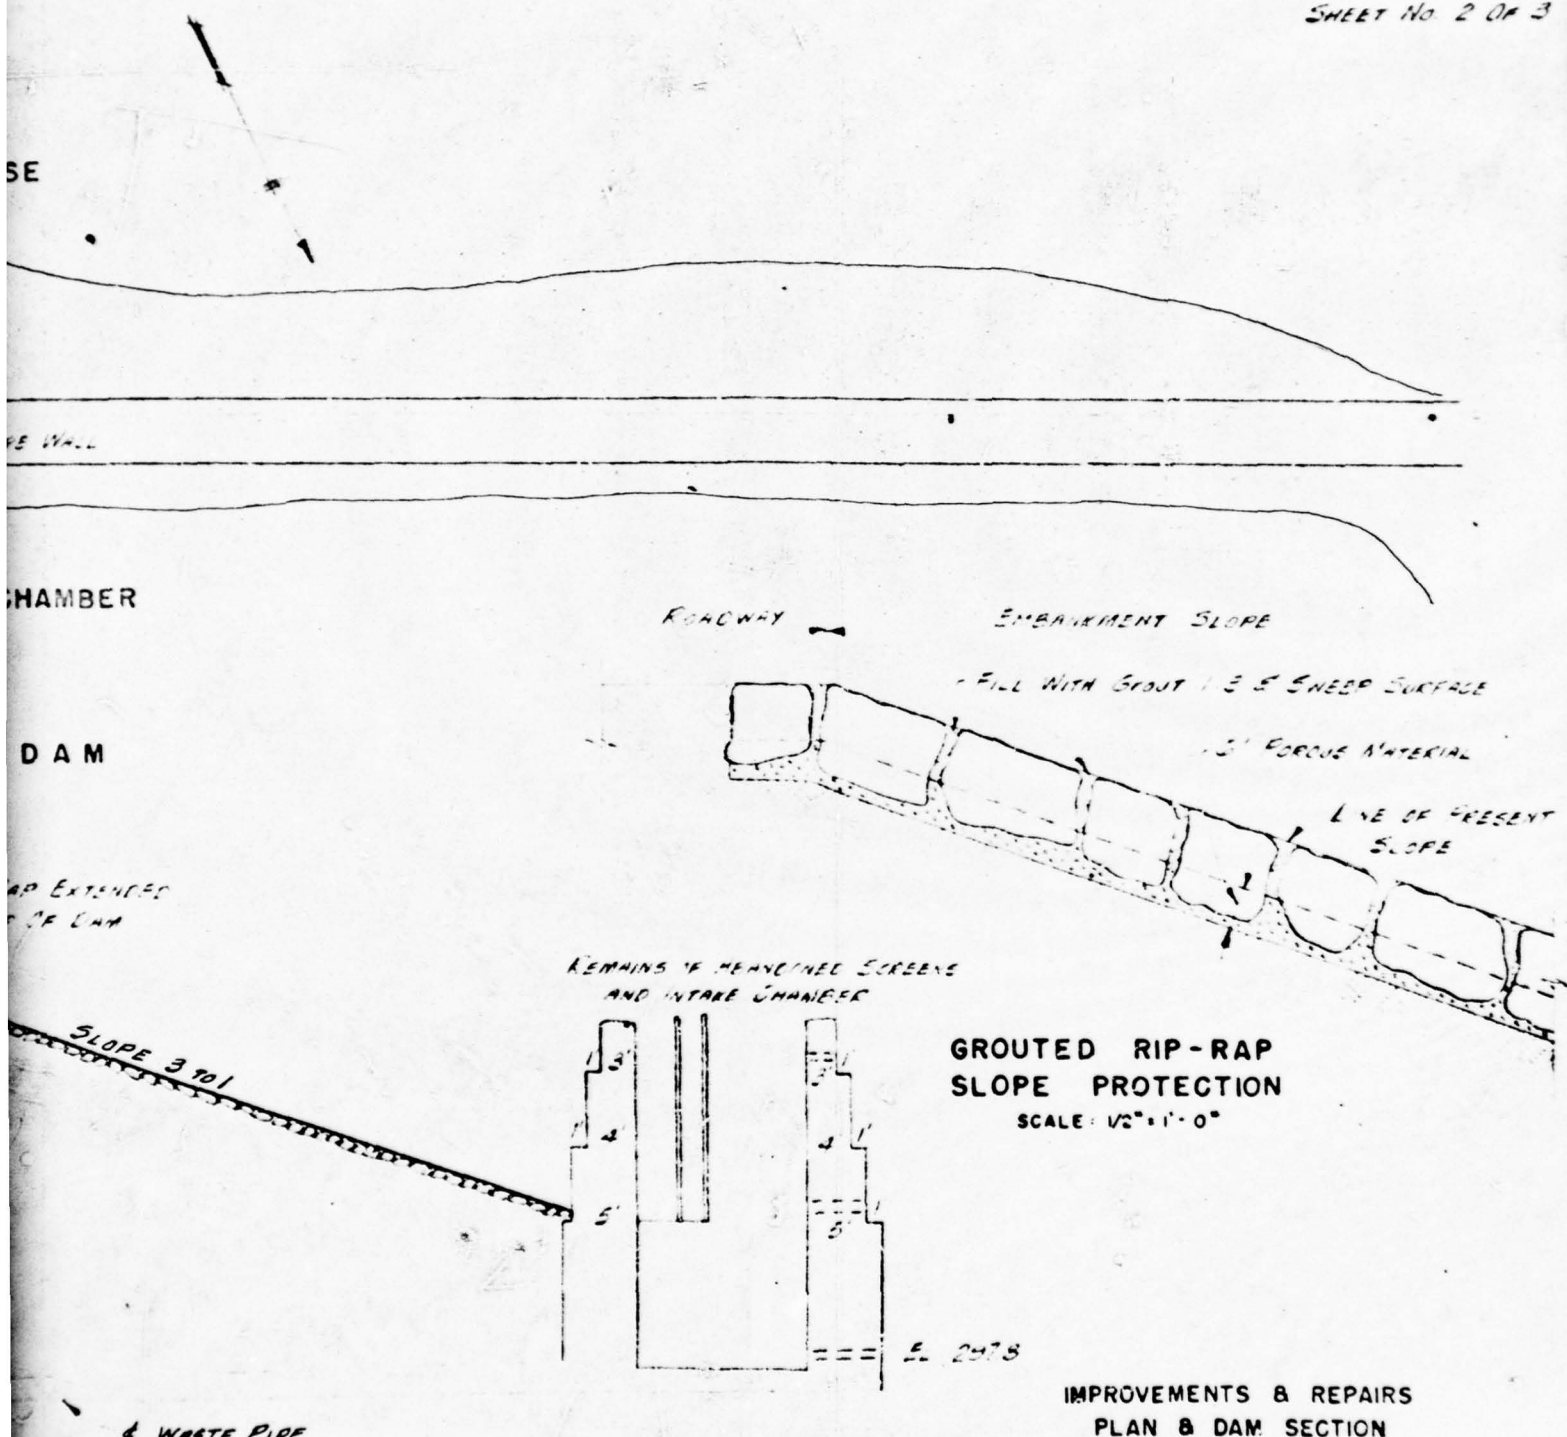
PLATE 2

Specifications for the construction of the embankment are not available. However, as indicated by these available plans, (Plate 2) the embankment material downstream of the core wall was designed to be a 'gravel or other coarse material' and the material upstream of the core wall is 'puddle'. Riprap extends from the edge of the road at the crest of the dam and covers the entire upstream face of the dam. Approximately the upper 10 feet of masonry riprap is set in concrete.

Repairs to the embankment consisted of placing and compacting impervious fill on the upstream embankment where settlement or erosion had occurred. Riprap consisting of stones weighing between 50 and 150 pounds were specified for placement on the top end of the upstream face of the embankment. The riprap was placed on a 6-inch layer of gravel and other porous material and the openings between the stones grouted after placement. (See Plate 2)

A mixed fill consisting of soil and trash has been dumped along the downstream slope adjacent to the spillway (Photo 2). The approximate extent of this fill has been superimposed on the original plan of the dam shown in Plate 3. It was reported that the only purpose of the fill was to allow vehicles room to turn around at the end of the road over the dam crest.

APPROXIMATE EXTENT
OF MISCELLANEOUS
FILL

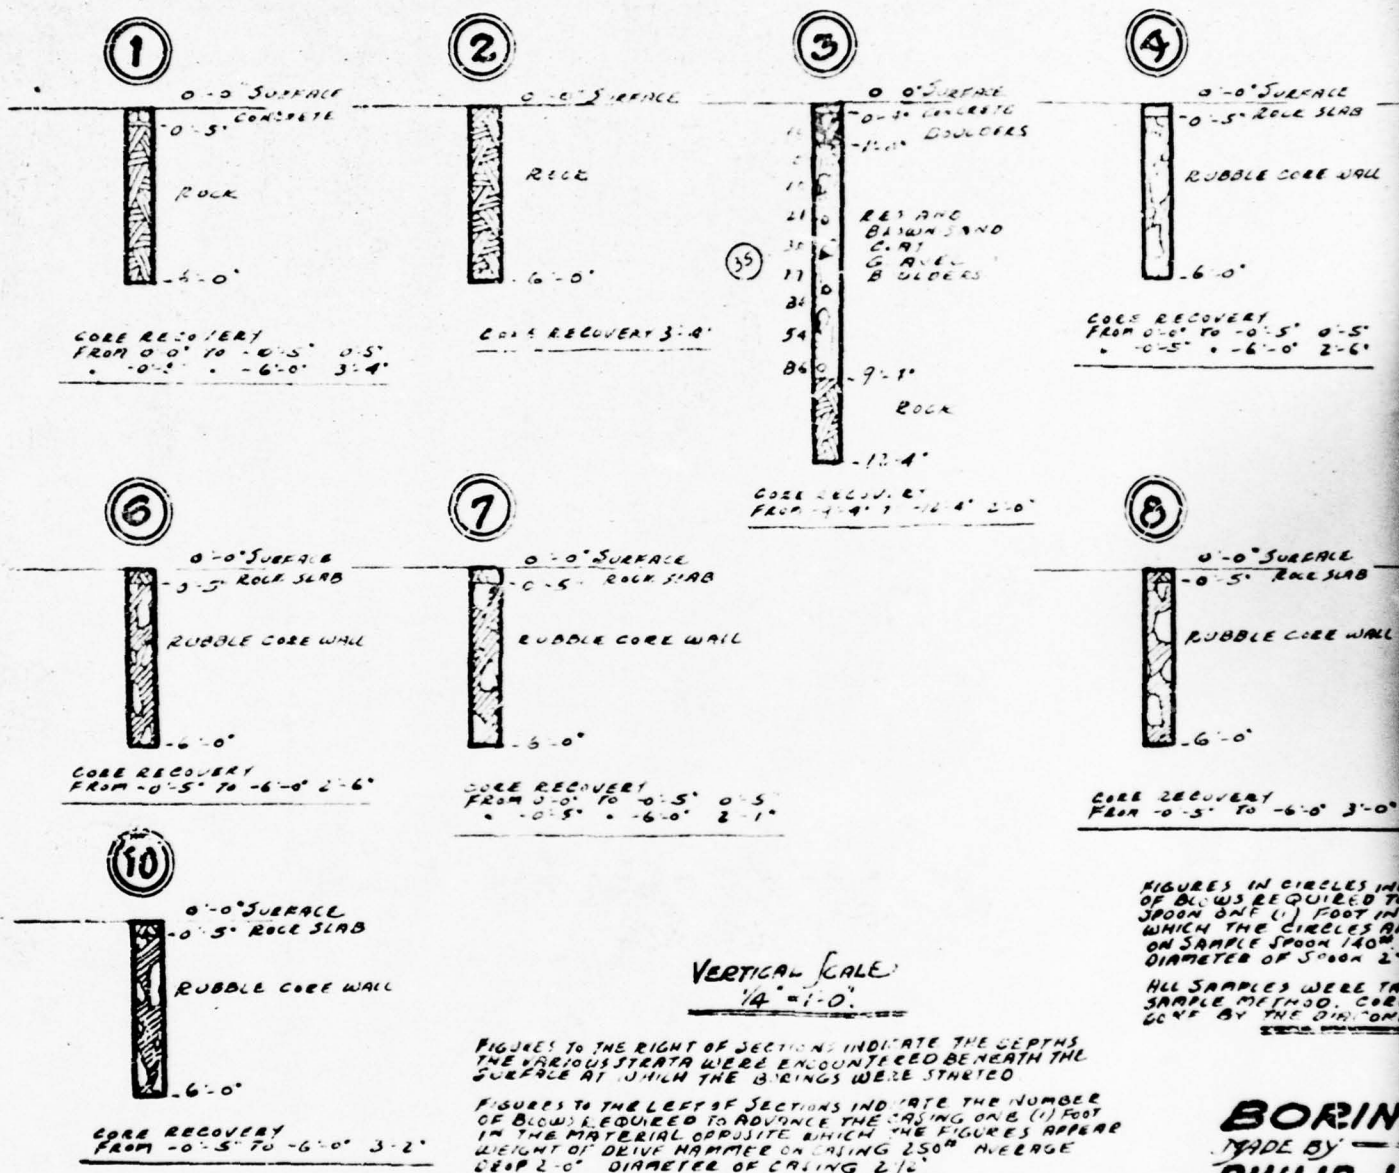
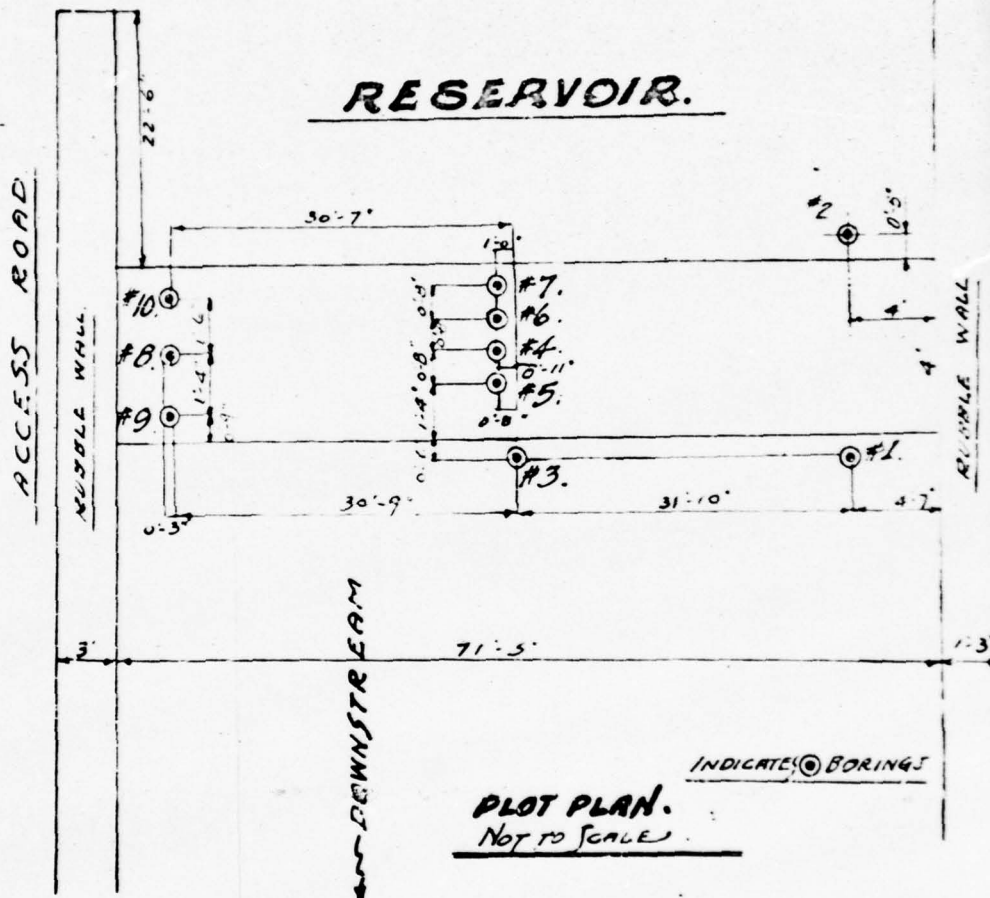
DIAMOND DRILL BORINGS

Copies of these drawings are included as Plates 2, 4, and 5 of this report. Plans and sections of the dam and spillway are also presented on a drawing submitted with a letter from Clyde Potts Associates dated July 28, 1958. (See Plate 3) A drawing dated May 27, 1958 showing the location and logs of borings taken in the spillway and used to develop the cross-section of the spillway is shown on Plate 6.
